**Flood Control Project Maintenance  
Levee Inspections**

**Fall 2016 Levee Maintenance Deficiency Summary Report**

**Sacramento River Basin**

<b>ST0003</b>	Overall LMA Rating	Total LMA Miles	* Overall LMA Threshold Percent is less than 10.00%; however, U Rated Miles are present, so the Overall LMA Rating is M instead of A.					
<b>Sutter Maintenance Yard East Levee Sacramento River</b>	<b>M *</b>	<b>26.82</b>						
Rated Item	Maintenance Deficiency				Enforcement		Design & System Obsolescence	
	M Miles	U Miles	M + 4U Miles	Threshold %	M Miles	U Miles	M Miles	U Miles
<i>Earthen Levee</i>								
Vegetation	0.83		0.83	3.10%	0.01			
Trim / Thin Trees	0.07		0.07	0.26%				
Encroachments					1.83	0.06		
Animal Control	0.08	0.01	0.12	0.45%				
Slope Stability	0.05		0.05	0.19%				
Erosion / Bank Caving	0.02		0.02	0.08%				
<i>Supplemental</i>								
2015 USACE Erosion Survey, DRAFT	0.36		0.36	1.34%				
DWR UCIP Field Study					0.38	0.11		
<i>LMA Totals:</i>	1.41	0.01	1.45	5.41% *	2.22	0.17	0.00	0.00
<b>Unit No. 01 Sacramento River LB</b>	Overall Unit Rating	Total Unit Miles	* Overall Unit Threshold Percent is less than 10.00%; however, U Rated Miles are present, so the Overall Unit Ra

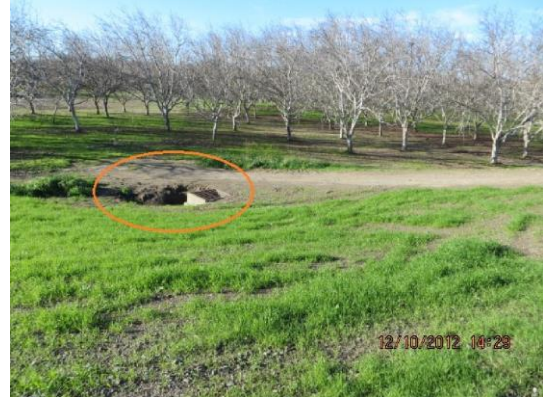
Photo 2 of 2 : UCIP\_FA\_2016\_50584\_47334.jpg

FS\_ID:50584  
DS\_ID:17369  
EP\_NO: 9510  
Repair Type: Urgent  
Crossing Status: Found  
UCIP Comments: 10/31/2016 No repairs have been made here yet. Bad erosion stil present at the WS toe distridution box.(DWR Sutter Yard- AFreitag)6/3/2016 Bad erosion stil present all around the WS surge box. Pipes were flowing water at the time of inspection and the bottom of the erosion hole was wet and had standing water in it indicating a leak coming from the surge box. (DWR Sutter Yard - afreitag)4/14/2016 Heavy scour still present around surge box on WS exposing pipe. Levee caved in and severely damaged around surge box. Erosion around CMP riser on WS cited previously not found. (DWR UCIP - kfazel)4/2/2015 Pipe leaks during high water. It is suspected that the screw gate does not fully close and may need to be cleaned to allow it to close fully. (DWR Sutter Yard - afreitag)7/2/2014 Same as last inspection. (DWR Sutter Yard - afreitag)12/19/2013 Same as last inspection. (DWR Sutter Yard - afreitag)7/23/2013 Water was flowing from the WS to LS ditch. Not sure where water flow was originating. All erosion problems are still present. (DWR Sutter Yard - afreitag)12/10/2016 Soil erosion around CMP riser and surge concrete box on WS damaged due to overflow. Pump not found. Flap gate missing on WS concrete box. WS slope eroded. Structure might have been used as drainage structure. This needs to be determined during routine inspection. (DWR UCIP - pamatya)

Waterside view: overview of concrete surge box

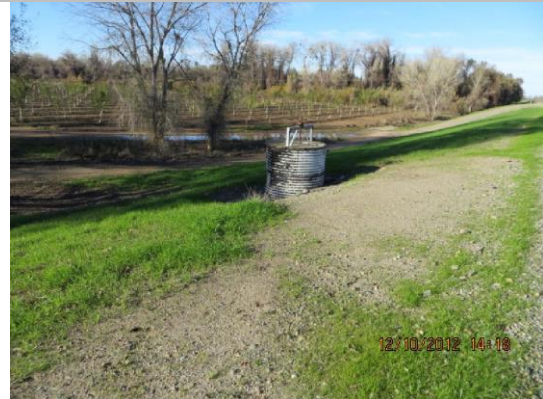
Photo 1 of 2 : UCIP\_FA\_2016\_50585\_47343.jpg

Comment Code					
Inspector Comment					
FS_ID:50585 DS_ID:17340 EP_NO: 9511 Repair Type: Non-Urgent Crossing Status: Found UCIP Comments: 10/31/2016 Abandoned. (DWR Sutter Yard-AFreitag)6/14/2016 Pipe was internally cleaned and camera inspected on 11/6/2015 by Nor-Cal Pipeline Services. The 48" cmp pipe section that runs through the levee was deemed to be in good condition. After the LS levee toe the pipe changes to a 48" concrete box culvert for under the roadway and that showed signs of some cracking. After the inspection the WS end was capped to keep sediment out until further abandonment can be achieved.4/16/2016 A wooden board has been placed on WS outlet of pipe to prevent sediment from entering pipe. This is a temporary repair measure by Sutter Yard until pipe can be grouted. Need to contact owner to ensure pipe's proper abandonment. Blockage of pipe outlet by wooden board or sediment will pose a hazard during high water. Pipe owner unclear, as landowner differs on LS and WS.4/2/2015 Pipe has been selected for internal camera inspection.Outlet pipe silted on WS. Inlet structure damaged on LS. Not properly abandoned.7/2/2014 Same as last inspection.12/19/2013 Same as last inspection.7/23/2013 Same as last inspection. FIELD_STRUCT_DESC: *ABANDONED* 48-inch corrugated metal drainage pipe through the levee, 16.5 feet below the crown. Slide gate in a 60-inch corrugated metal pipe (CMP) riser on the waterside (WS) slope. Landside (LS) end of pipe on east side of River Road. Pipe is not in use but is operable. (Permit No. 9511, 1974 - Moresco). [Additional Reference(s): DWR Levee Log, 2002. USACE Sacramento O&M Manual 136, March 1960 (HLM 13.37)]. FS Date: 11/2/2016 9:06:25 AM

Waterside view: CMP riser with slide gate

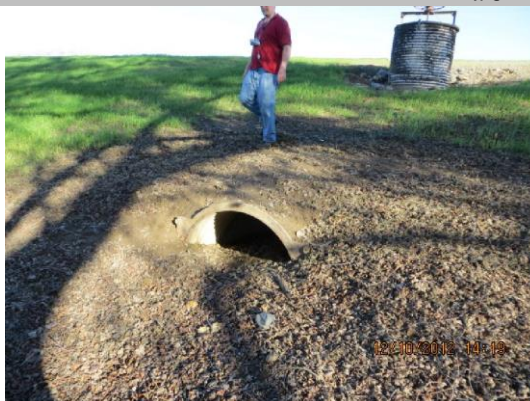
Photo 2 of 2 : UCIP\_FA\_2016\_50585\_47342.jpg

FIELD\_STRUCT\_DESC: \*ABANDONED\* 48-inch corrugated metal drainage pipe through the levee, 16.5 feet below the crown. Slide gate in a 60-inch corrugated metal pipe (CMP) riser on the waterside (WS) slope. Landside (LS) end of pipe on east side of River Road. Pipe is not in use but is operable. (Permit No. 9511, 1974 - Moresco). [Additional Reference(s): DWR Levee Log, 2002. USACE Sacramento O&M Manual 136, March 1960 (HLM 13.37)].  
FS Date: 11/2/2016 9:06:25 AM

Waterside view: overview of CMP riser and outlet pipe

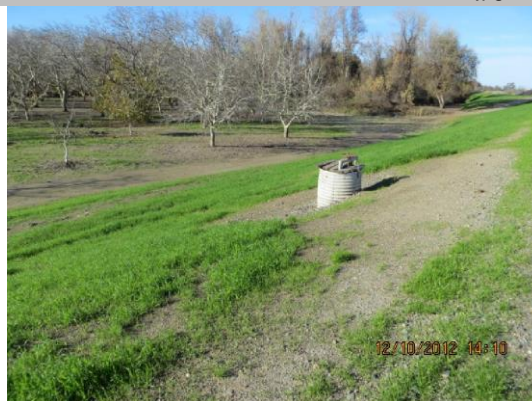
Photo 1 of 2 : UCIP\_FA\_2016\_50586\_47349.jpg

FS\_ID:50586  
DS\_ID:17361  
EP\_NO: N/A  
Repair Type: Non-Urgent  
Crossing Status: Indicator Found  
UCIP Comments: 10/31/2016 Appears abandoned. WS pipe end buried. (DWR Sutter Yard- AFreitag)6/14/2016 WS pipe end was dug up for a internal camera inspection. The WS slide gate was sealed shut and would not open so the inspection was only done form the WS pipe end to the WS slide gate (33.1ft). The pipe showed some signs of heavy rusting but no visible holes or other signs of deterioration were found. After the inspection the WS pipe end was capped and reburied until further abandonment can be achieved.4/2/2015 Only CMP riser on WS. Pipe has been selected for internal camera inspection. Only CMP riser found on WS.7/2/2014 Same as last inspection.12/19/2013 Same as last inspection.7/23/2013 Same as last inspection.  
FIELD\_STRUCT\_DESC: 24-inch corrugated metal drainage pipe through the levee, 16 feet below the crown, not found in 2015. Slide gate in a corrugated metal pipe (CMP) riser on the waterside (WS) end, found in 2015. [Additional Reference(s): DWR Levee Log, 2002. USACE Sacramento O&M Manual 136, March 1960 (HLM 13.92)].

Waterside view: CMP riser with slide gate

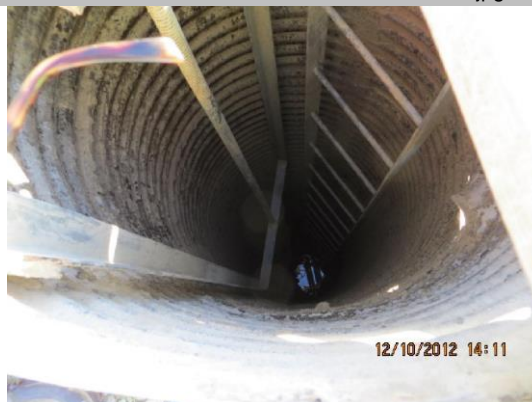
Photo 2 of 2 : UCIP\_FA\_2016\_50586\_47348.jpg

Waterside view: inside CMP riser

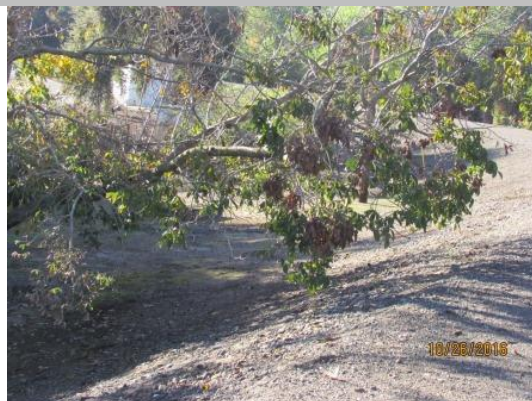
Photo 1 of 1 : FA\_2016\_ST0003\_264\_73\_20161104\_00139.jpg

LM Start	14.32	Rating **	M	Issue No.	73
LM End	14.32	Issue Type +	Ma	Location *	LS
Category	Earthen Levee			GPS Latitude/Longitude	
				Start	End
Item	Trim / Thin Trees			39.318793 °	39.318793 °
				-122.015832 °	-122.015832 °
DWR ID	DWR_ST0003_01_f_2016_73				
Comment Code					
T1 : Trim trees to at least five feet above ground level.					
Inspector Comment

View of a tree limb hanging over the landside slope.

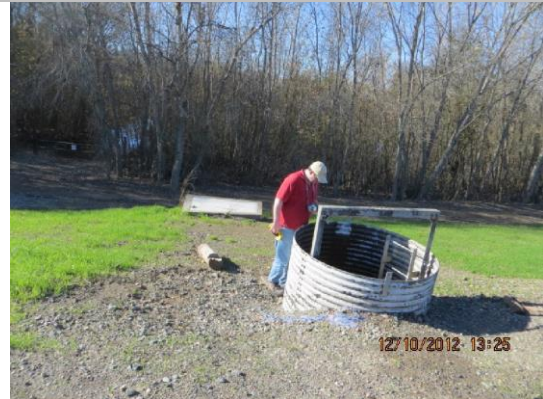
Photo 1 of 2 : UCIP\_FA\_2016\_50589\_47363.jpg

FS\_ID:50589  
DS\_ID:17331  
EP\_NO: 1833  
Repair Type: Non-Urgent  
Crossing Status: Found  
UCIP Comments: 10/31/2016 Leaky pipe marker was not present at inspection but nothing appears to have changed with this crossing. (DWR Sutter Yard- A Freitag) 6/15/2016 No changes made to this crossing. Leaky pipe marker still present. 4/14/2016 Levee slightly caved in one side of surge box on WS. 4/2/2015 Leaks during high water. Distribution box plugged with cement concrete on LS. Other concrete box plugged with concrete on WS. New steel pipe (about 16 inch diameter) sleeved through CMP pipe. It is visible inside CMP riser. 7/2/2014 Same as last inspection. 12/19/2013 Same as last inspection. 7/23/2013 Same as last inspection.  
FIELD\_STRUCT\_DESC: 42-inch corrugated metal irrigation pipe through the levee, 14.2 feet below the crown. 16-inch (approximate) pipe has been sleeved through the 42-inch corrugated metal pipe (CMP), with annular space pressure grouted. Pump structure on the waterside (WS) bank, not found in 2016. Concrete surge box at the WS toe. Slide gate in a CMP riser on the WS slope. Concrete distribution box on the landside (LS) across River Road. Phone number provided is 916-802-8293. (Permit No. 1833, 1953 - Carter). [Additional Reference(s): DWR Levee Log, 2002. USACE Sacramento O&M Manual 136, March 1960 (HLM 14.55)].

Waterside view: CMP riser with slide gate and surge box

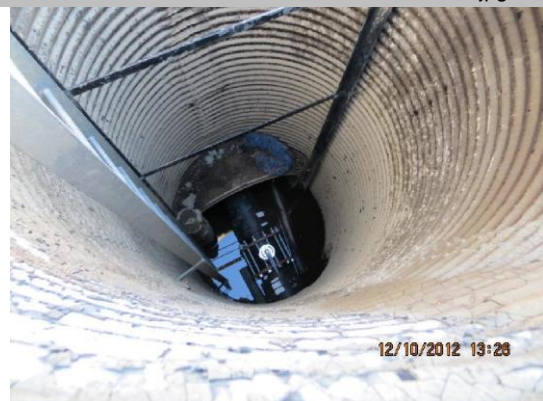
Photo 2 of 2 : UCIP\_FA\_2016\_50589\_47362.jpg

Waterside view: new steel pipe sleeved through CMP pipe.

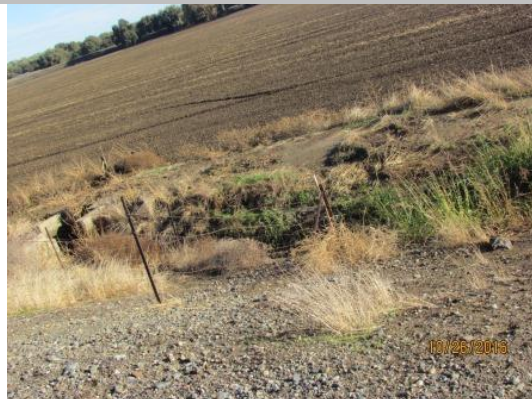
Photo 1 of 1 : FA\_2016\_ST0003\_264\_71\_20161104\_00140.jpg

LM Start	15.17	Rating **	M	Issue No.	71
LM End	15.48	Issue Type +	En	Location *	LS
Category	Earthen Levee			GPS Latitude/Longitude	
				Start	End
Item	Encroachments			39.330578 °	39.333842 °
				-122.018485 °	-122.022225 °
DWR ID	DWR_ST0003_01_f_2016_71				
Comment Code					
DT : Ditch					
Inspector Comment

View of a ditch along the landside toe.

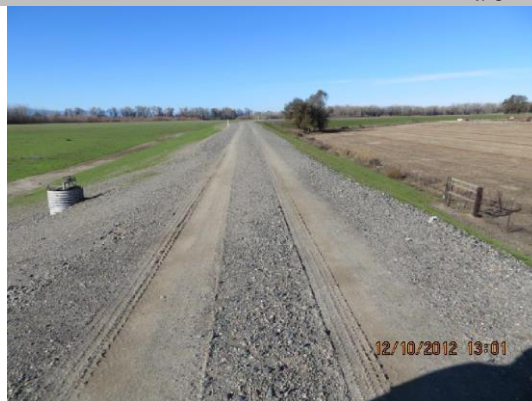
Photo 1 of 2 : UCIP\_FA\_2016\_50591\_47371.jpg

Comment Code					
Inspector Comment					
FS_ID:50591 DS_ID:17333 EP_NO: 9506 Repair Type: Non-Urgent Crossing Status: Found UCIP Comments: 10/31/2016 Minor erosion caused by rain runoff starting at the top of the WS headwall. REst of crossing appears in good condition. (DWR Sutter Yard- AFreitag)6/15/2016 Both pipe ends were underwater but appear to be in good condition.4/2/2015 Pipe and ditches were full of water. Everything seemed to be in good shape.Water full on inlet and outlet of the structure.7/2/2014 Same as last inspection.12/19/2013 Same as last inspection.7/23/2013 Same as last inspection. FIELD_STRUCT_DESC: 24-inch irrigation pipe of an unknown material through the levee, 16.5 feet below the crown. Pump in the floodway. Irrigation transfer ditch on the waterside (WS) to concrete surge box at the WS toe. Slide gates in a corrugated metal pipe (CMP) riser on the WS slope. Discharges into a concrete distribution box at the landside (LS) toe. (Automatic Board Order (ABO) issued as Permit No. 9506, 1974 - Carter). [Additional Reference(s): DWR Levee Log, 2002. USACE Sacramento O&M Manual 136, March 1960 (HLM 15.46)]. FS Date: 11/2/2016 9:22:15 AM

Crown view: overview (both sides of the levee)

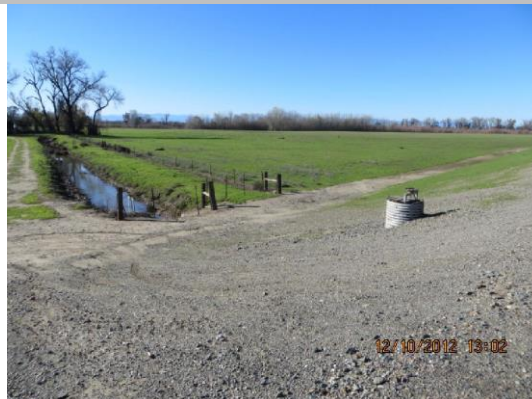
Photo 2 of 2 : UCIP\_FA\_2016\_50591\_47370.jpg

Waterside view: CMP riser, inlet box and water transfer ditch

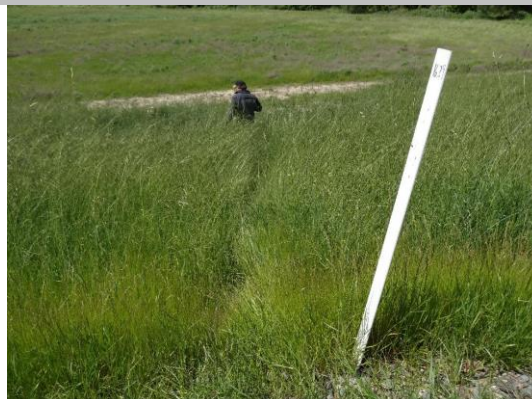
Photo 1 of 2 : UCIP\_FA\_2016\_50595\_75096.jpg

FS\_ID:50595  
DS\_ID:17337  
EP\_NO: N/A  
Repair Type: Non-Urgent  
Crossing Status: Found  
UCIP Comments: 11/1/2016 Abandoned. Pipe is buried and not visible but a white marker on WS shoulder shows its location. (DWR Sutter Yard- A Freitag)6/15/2016 Pipe was dug up and internally cleaned and camera inspected on 11/19/2015 by Nor-Cal Pipeline Services. Pipe section through the levee is 88ft long and showed signs of rusting but no holes or other deterioration was found. The WS flap gate was broken during excavation but doesn't pose an issue as the pipe was capped and reburied until further abandonment can be achieved. Unfortunately the pipe was not photographed when exposed.4/14/2016 Same as last inspection.4/2/2015 Unable to locate. Pipe has been selected to be dug up and internally camera inspected.7/2/2014 Unable to locate.12/19/2013 Unable to locate7/23/2013 Same as last inspection. Unable to locate.

View from crown down WS slope at location of crossing.

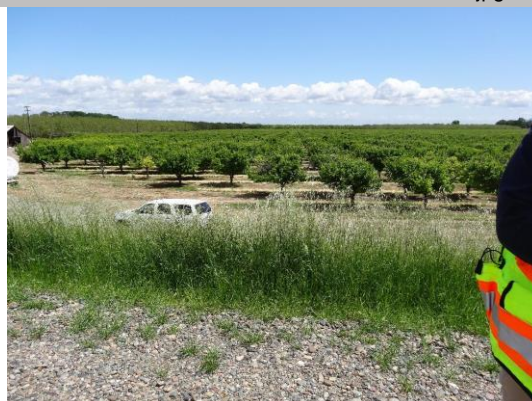
Photo 2 of 2 : UCIP\_FA\_2016\_50595\_75097.jpg

View of LS from crown at location of crossing.

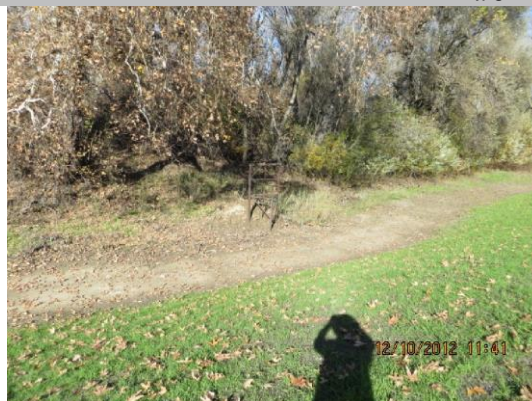
Photo 1 of 2 : UCIP\_FA\_2016\_50597\_47380.jpg

FS\_ID:50597  
DS\_ID:17349  
EP\_NO: 9500  
Repair Type: Non-Urgent  
Crossing Status: Indicator Found  
UCIP Comments: 11/1/2016 Abandoned. (DWR Sutter Yard-AFreitag)6/15/2016 Abandoned- WS slide gate and LS distribution box are silted over.4/16/2016 Same as last inspection. Appears abandoned and should be done so properly.4/2/2015 WS slide gate and LS distribution box are still silted over.Seems abandoned as slide gate and distribution box silted.7/2/2014 Same as last inspection.12/19/2013 Same as last inspection.7/23/2013 Same as last inspection.  
FIELD\_STRUCT\_DESC: \*ABANDONED\* 48-inch corrugated metal irrigation and drainage pipe through the levee, 17 feet below the crown, not found in 2016. Slide gate on the waterside (WS), found in 2016. 8-inch steel pipe sleeved through the 48-inch pipe during the summer months, not found in 2016. Discharges into a concrete distribution box on the landside (LS) toe. (Automatic Board Order (ABO) issued as Permit No. 9500, 1974 - Zumwalt Orchards, Inc.). [Additional Reference(s): DWR Levee Log, 2002. USACE Sacramento O&M Manual 136, March 1960 (HLM 16.42)].

Waterside view: overview of slide gate

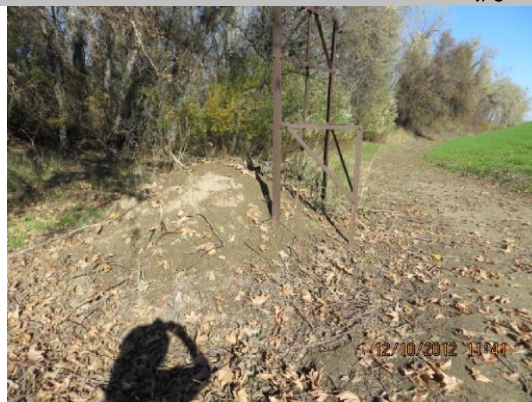
Photo 2 of 2 : UCIP\_FA\_2016\_50597\_47379.jpg

Waterside view: slide gate on steel structure

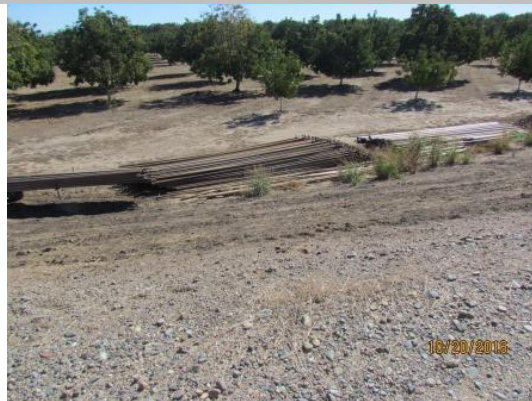
Photo 1 of 1 : FA\_2016\_ST0003\_264\_63\_20161104\_00145.jpg

LM Start	17.97	Rating **	M	Issue No.	63
LM End	17.97	Issue Type +	En	Location *	LS
Category	Earthen Levee			GPS Latitude/Longitude	
				Start	End
Item	Encroachments			39.358920 °	39.358920 °
				-122.007537 °	-122.007537 °
DWR ID	DWR_ST0003_01_f_2016_63				
Comment Code					
EQ : Equipment					
Inspector Comment

View of the ag equipment along the landside toe.

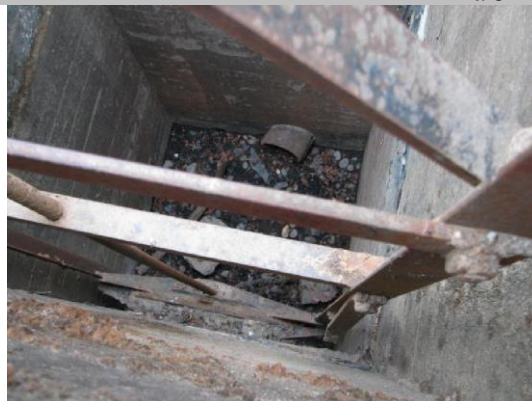
Photo 2 of 2 : UCIP\_FA\_2016\_50603\_47392.jpg

Waterside view: inside gate riser

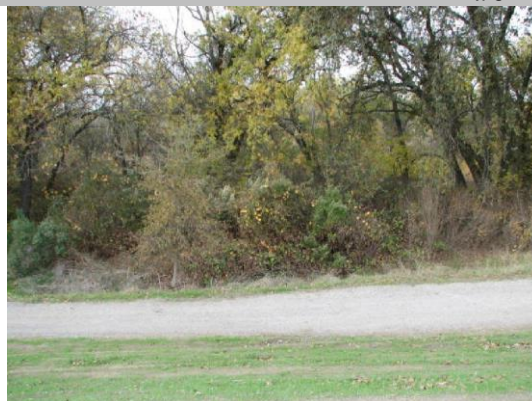
Photo 1 of 2 : UCIP\_FA\_2016\_50612\_47449.jpg

FS\_ID:50612  
DS\_ID:17487  
EP\_NO: N/A  
Repair Type: Non-Urgent  
Crossing Status: Found  
UCIP Comments: 11/1/2016 Abandoned.(DWR Sutter Yard-AFreitag)6/3/2016 Abandoned crossing.4/2/2015 Same as last inspection. Slide Gate WS not found. An abandoned pump and steel pipe found on WS. A 6 ft x 8 ft concrete distribution box with a CMP found on LS. Box filled with soil. An abandoned crossing.7/2/2014 Same as last inspection.12/19/2013 Same as last inspection.7/24/2013 Same as last inspection.  
FIELD\_STRUCT\_DESC: \*ABANDONED\* 36-inch corrugated metal drainage pipe through the levee, invert 21.7 feet below the crown. Abandoned pump and steel pipe found on the waterside (WS). 6 foot by 8 foot concrete distribution box with the 36-inch corrugated metal pipe found on the landside (LS). [Additional Reference(s): USACE Sacramento O&M Manual 136, March 1960 (HLM 19.61)].  
FS Date: 11/2/2016 9:43:02 AM

Waterside view: overview

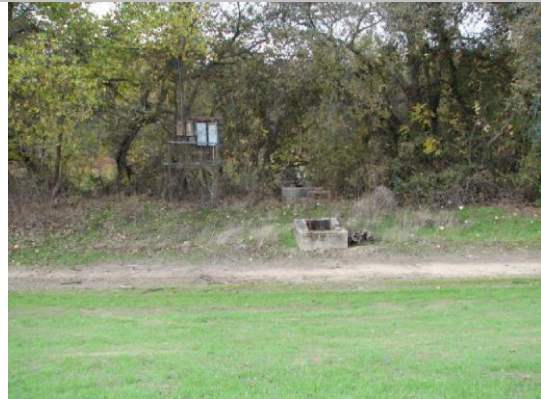
Photo 1 of 2 : UCIP\_FA\_2016\_50613\_47459.jpg

FS\_ID:50613  
DS\_ID:17370  
EP\_NO: 9496  
Repair Type: Non-Urgent  
Crossing Status: Found  
UCIP Comments: 11/1/2016 Abandoned. (DWR Sutter Yard-AFreitag)6/3/2016 Abandoned crossing4/2/2015 Same as last inspection. Only one pump found on WS. An abandoned surge box found on WS and pipe is grouted with cement. Two 16-inch steel pipe found on pump station along with two electrical conduits. A concrete distribution box found on LS with 20-inch CMP. Appears abandoned crossing.7/2/2014 Same as last inspection.12/19/2013 Same as last inspection.7/24/2013 Same as last inspection.  
FIELD\_STRUCT\_DESC: \*ABANDONED\* 20-inch corrugated metal irrigation pipe through the levee, 19.8 feet below the crown. (Not 24-inch pipe, as stated in the O&M Manual, Automatic Board Order, and Levee Log). Two vertical pumps on a pile structure on the waterside (WS) bank (one pump found in 2015). Slide gate in a concrete surge box on the waterside (WS) berm. Discharges into a concrete distribution box on the landside (LS) across the county road. Switch board on the platform on the WS bank. (Automatic Board Order (ABO) issued as Permit No. 9496, 1974 - Womble). [Additional Reference(s): DWR Levee Log, 2002. USACE Sacramento O&M Manual 136, March 1960 (HLM 20.05)].

Waterside view: overview

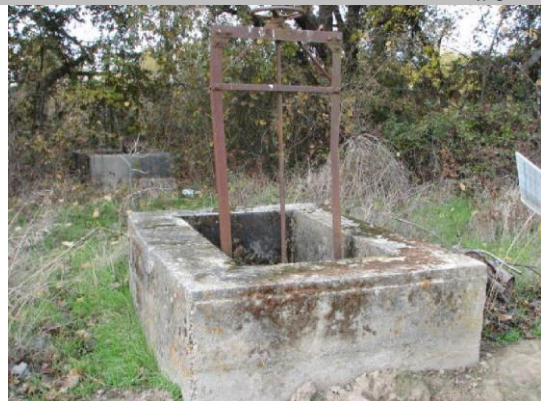
Photo 2 of 2 : UCIP\_FA\_2016\_50613\_47457.jpg

Waterside view: gate riser with slide gate

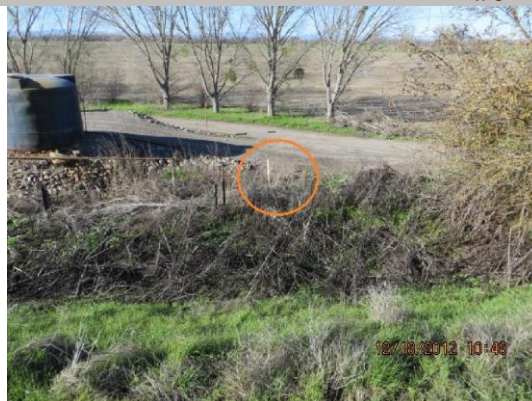
Photo 1 of 2 : UCIP\_FA\_2016\_49161\_47480.jpg

Landside view: overview gasoline indicator

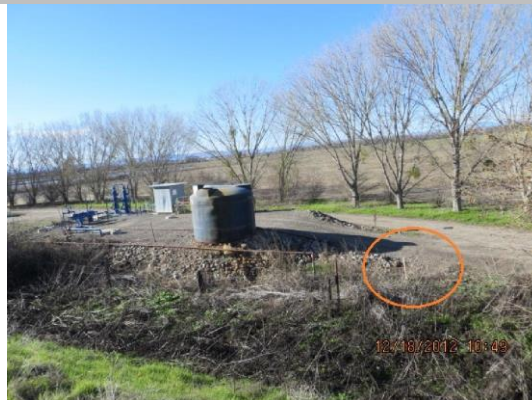
Photo 2 of 2 : UCIP\_FA\_2016\_49161\_47479.jpg

FS\_ID:49161  
DS\_ID:17531  
EP\_NO: 13534  
Repair Type: Non-Urgent  
Crossing Status: Indicator Found  
UCIP Comments: 6/3/2016 Crossing appears to be in good condition.4/6/2015 Same as last inspection. May need to add more substantial gasoline markers.7/7/2014 Same as last inspection.12/19/2013 Same as last inspection.7/22/2013 Same as last inspection.  
FIELD\_STRUCT\_DESC: 2.5-inch asphalt coated steel gas pipeline through the levee, 2.5 feet below the crown. A gas line marker found on the landside (LS). (Permit No. 13534, 1982 - Texaco, Incorporated).  
[Additional Reference(s): DWR Levee Log, 2002].  
FS Date: 6/16/2016 10:00:15 AM

Landside view: overview gasoline indicator

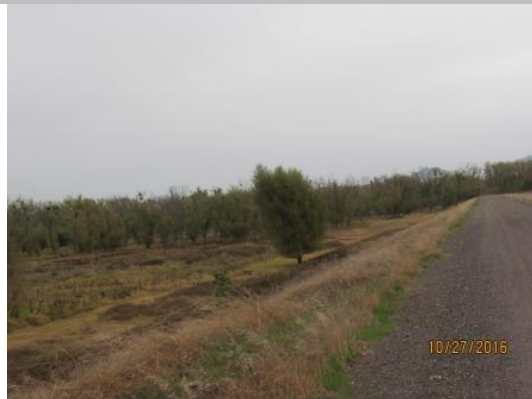
Photo 1 of 1 : FA\_2016\_ST0003\_265\_4\_20161104\_00007.jpg

LM Start	2.02	Rating **	M	Issue No.	4
LM End	2.19	Issue Type +	Ma	Location *	WS
Category	Earthen Levee			GPS Latitude/Longitude	
				Start	End
Item	Vegetation			39.227865 °	39.227868 °
				-121.962233 °	-121.959095 °
DWR ID	DWR_ST0003_02_f_2016_4				
Comment Code					
V1 : Control annual grass and weeds on the levee slopes and easements.					
Inspector Comment

View of the waterside vegetation.

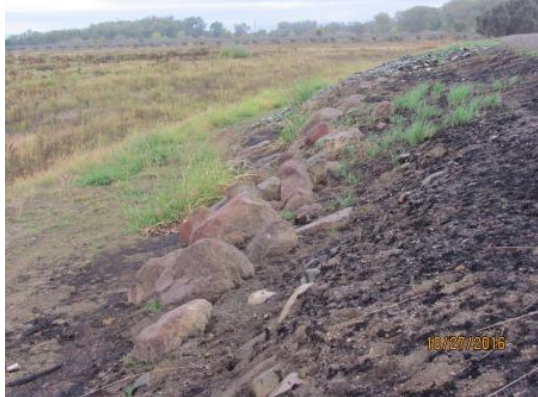
Photo 1 of 1 : FA\_2016\_ST0003\_266\_7\_20161104\_00004.jpg

View of the erosion along the waterside slope.

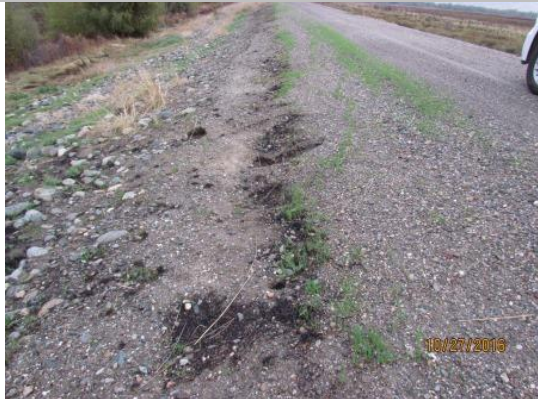
Photo 1 of 1 : FA\_2016\_ST0003\_266\_4\_20161104\_00005.jpg

View of the slope instability along the landside slope.

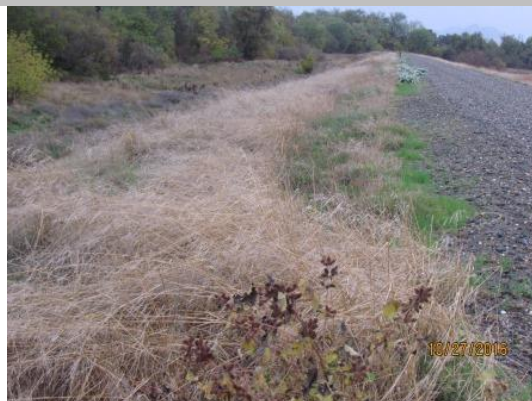
Photo 1 of 1 : FA\_2016\_ST0003\_266\_5\_20161104\_00006.jpg

LM Start	2.04	Rating **	M	Issue No.	5
LM End	2.29	Issue Type +	Ma	Location *	LS
Category	Earthen Levee			GPS Latitude/Longitude	
				Start	End
Item	Vegetation			39.244948 °	39.244898 °
				-121.963805 °	-121.959117 °
DWR ID	DWR_ST0003_03_f_2016_5				
Comment Code					
V1 : Control annual grass and weeds on the levee slopes and easements.					
Inspector Comment

View of the landside vegetation.

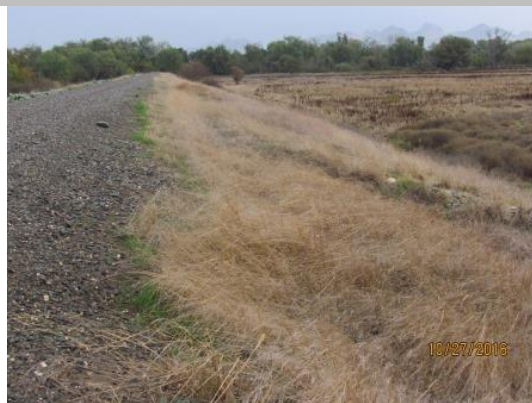
Photo 1 of 1 : FA\_2016\_ST0003\_266\_6\_20161104\_00007.jpg

LM Start	2.04	Rating **	M	Issue No.	6
LM End	2.29	Issue Type +	Ma	Location *	WS
Category	Earthen Levee			GPS Latitude/Longitude	
				Start	End
Item	Vegetation			39.244923 °	39.244898 °
				-121.963775 °	-121.959117 °
DWR ID	DWR_ST0003_03_f _ 2016_6				
Comment Code					
V1 : Control annual grass and weeds on the levee slopes and easements.					
Inspector Comment

View of the waterside vegetation.

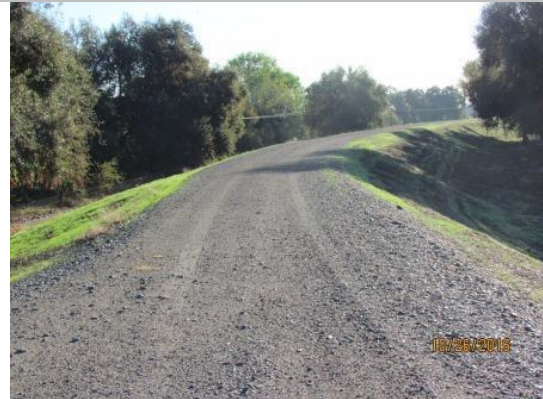
Photo 1 of 1 : FA\_2016\_ST0003\_267\_1\_20161104\_00001.jpg

LM Start	0.00	Rating **	A	Issue No.	1
LM End	0.00	Issue Type +	Ma	Location *	LS
Category	Earthen Levee			GPS Latitude/Longitude	
				Start	End
Item	Vegetation			39.338149 °	39.338149 °
				-122.022226 °	-122.022226 °
DWR ID	DWR_ST0003_04_f_2016_1				
Comment Code					
V1 : Control annual grass and weeds on the levee slopes and easements.					
Inspector Comment

View of the levee crown and landside slope.
